**Structural Performance
of
Christchurch CBD Buildings
in the
22 February 2011 Aftershock**

Stage 1 Expert Panel Report

**Pyne Gould Corporation Building
Hotel Grand Chancellor Building
Forsyth Barr Building**

30 September 2011

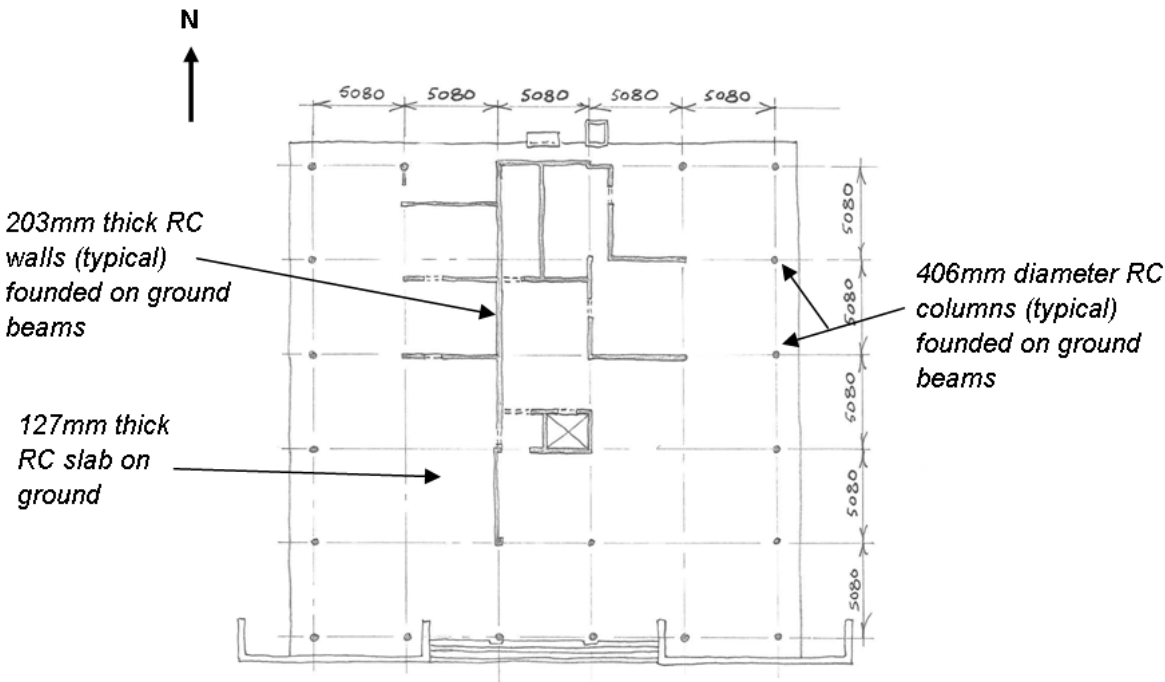
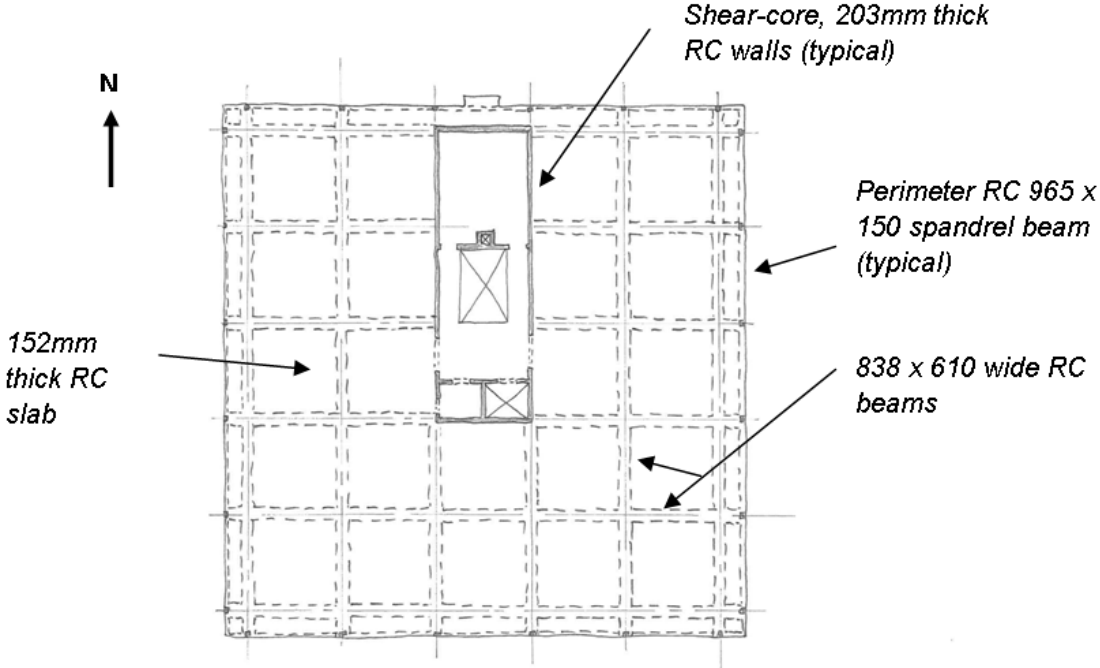
A feature of the building, that affected the way in which it responded to the 22 February 2011 aftershock, was that the structure between Ground Level and Level 1 was significantly stronger and stiffer than immediately above Level 1. Refer to Figures 3 and 4.

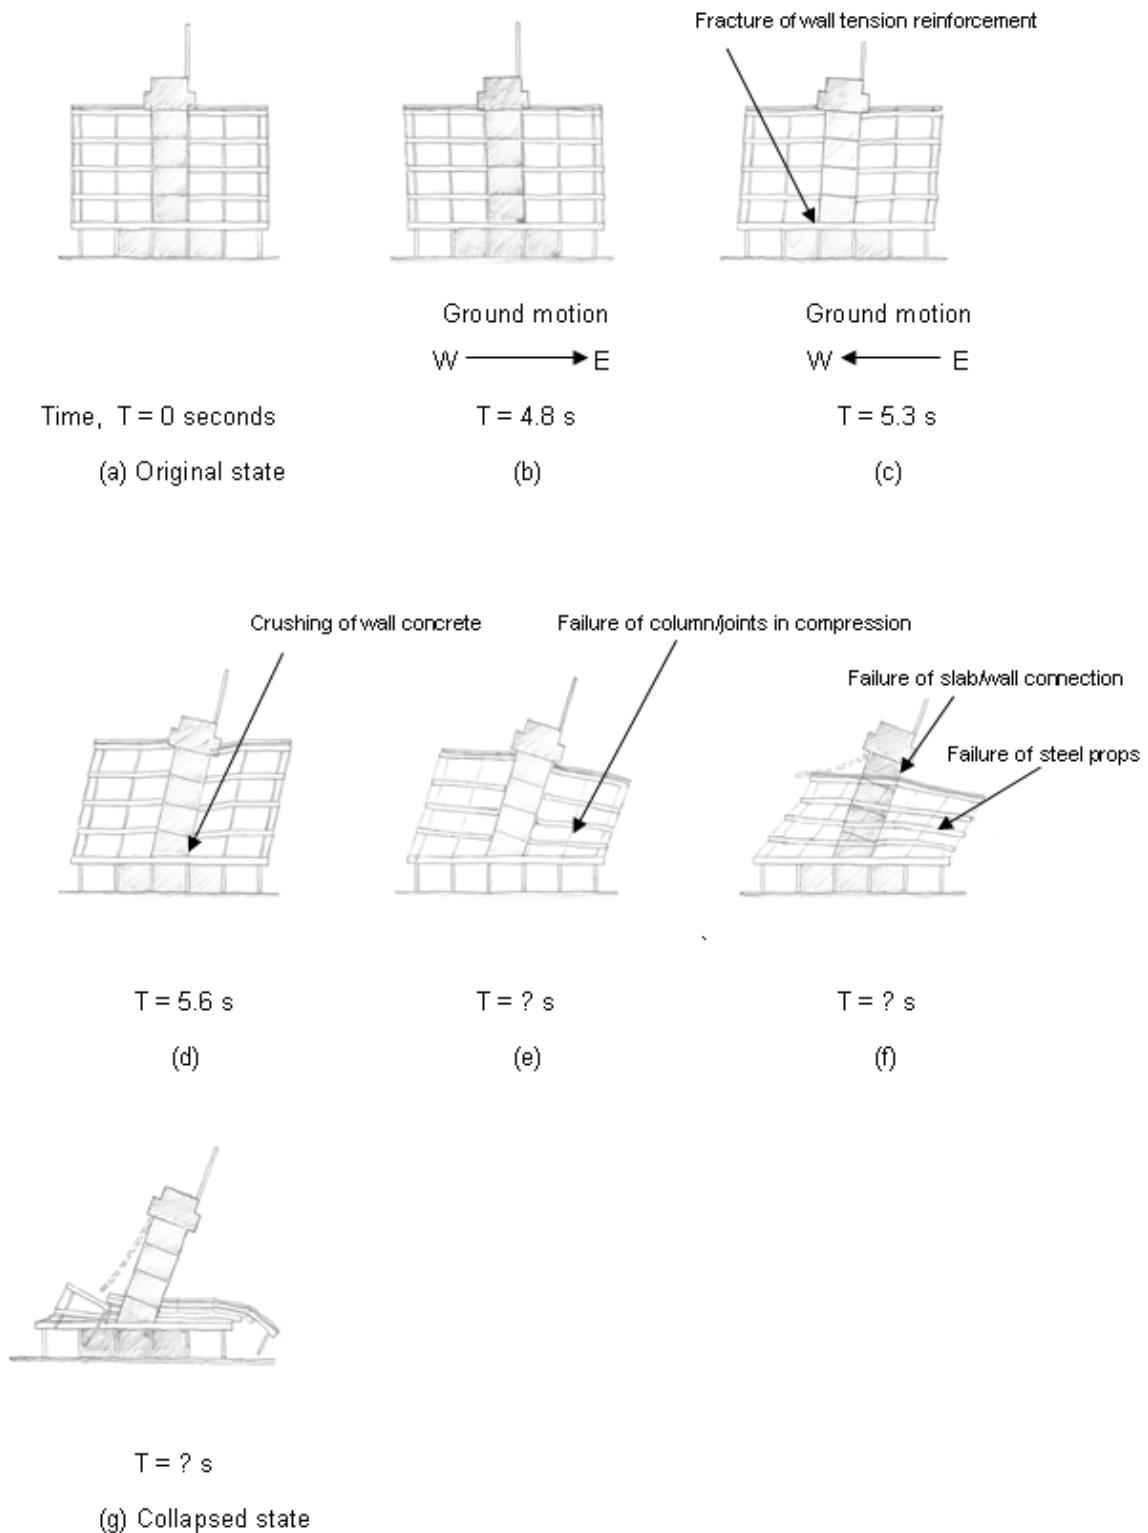
Analyses and site observations indicate the following sequence of collapse (refer Figure 5). The PGC building collapsed when the east and west reinforced concrete walls of the core between Level 1 and Level 2 failed during the aftershock. The west wall yielded in vertical tension, and then the east wall failed catastrophically in vertical compression. The ground floor structure stayed intact, virtually undamaged as it was significantly stronger and stiffer than the structure above. Torsional response (i.e., twisting of the building about a vertical axis) was not a significant factor. Once the west wall had failed, the horizontal deflections to the east increased markedly. The perimeter columns and/or joints between the columns and the beams, and the connections between the floor slabs and the shear-core failed consequentially at some levels, causing the floors to collapse.

Figure 5: Inferred collapse sequence

The reason the PGC building collapsed was that the shaking experienced in the east-west direction was almost certainly several times more intense than the capacity of the structure to resist it. In addition, the connections between the floors and the shear-core, and between the perimeter beams and columns, were not designed to take the distortions associated with the core collapse. Neither foundation instability nor liquefaction was found to be a factor in the collapse.

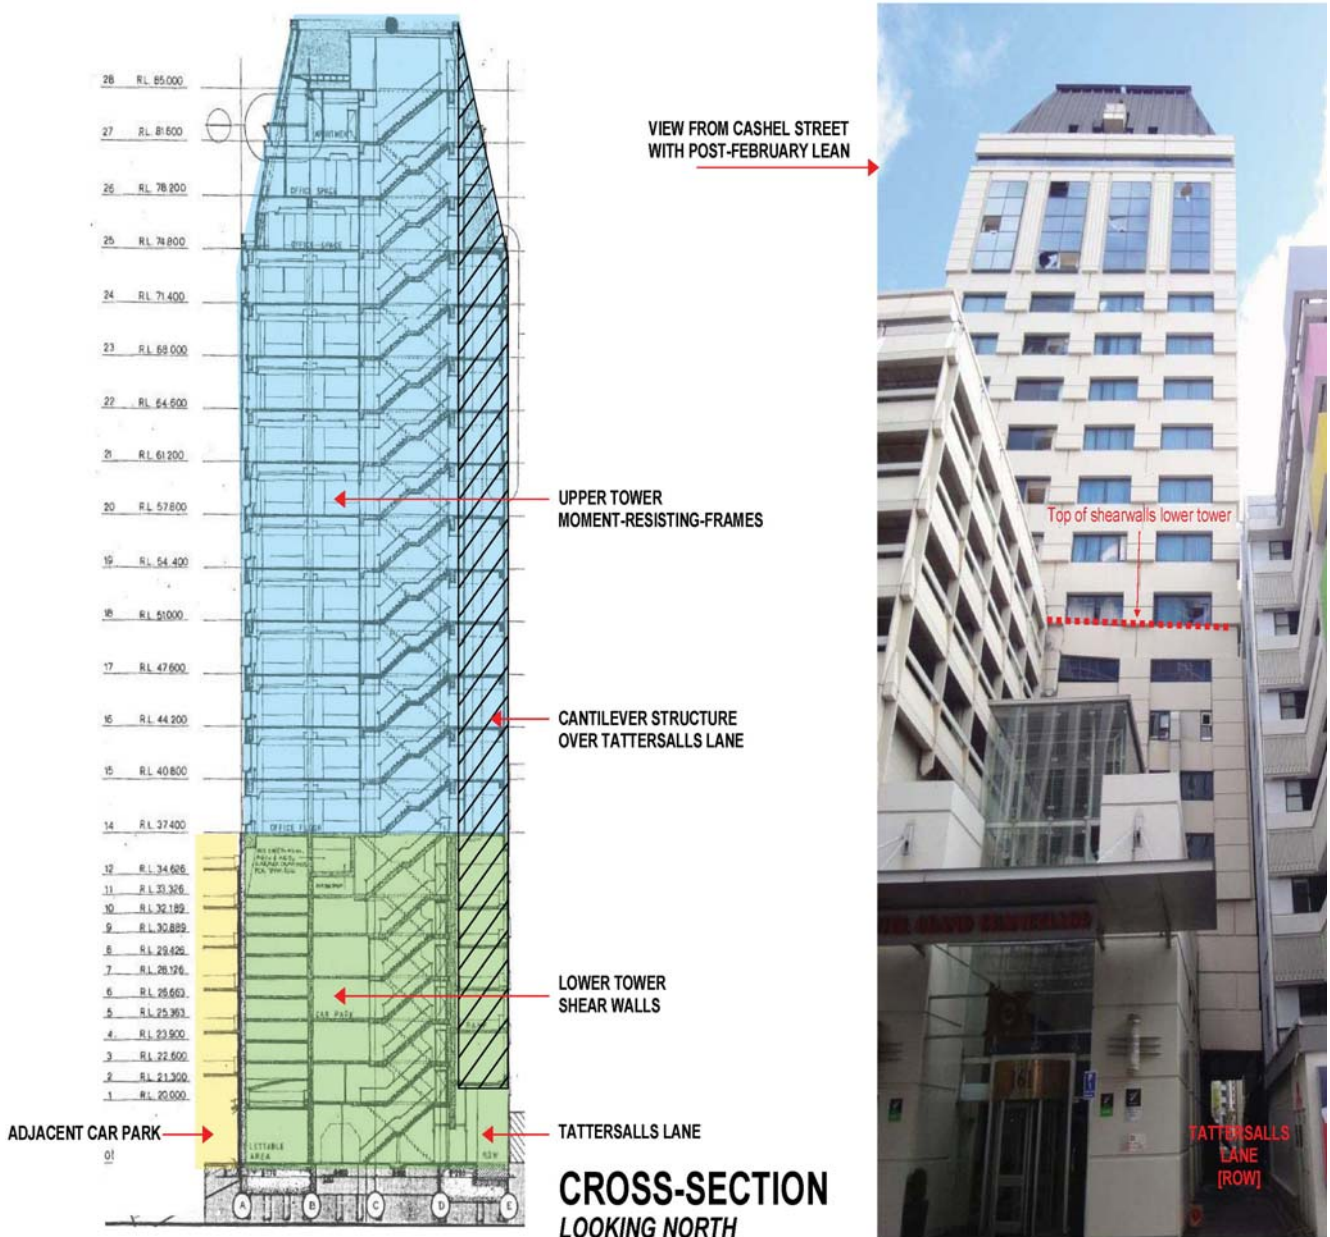
Figure 2: Plan showing Hotel Grand Chancellor cross-section (looking north) and a photograph showing the location of the shear wall (D5-6)

The Hotel Grand Chancellor structure has both vertical and horizontal structural irregularity. Vertical irregularity arises from the fact that the upper tower relies on frame action (moment-resisting reinforced concrete frames) for its seismic resistance while the lower tower relies on reinforced concrete shear walls. The two structural forms inherently have different stiffnesses and, if not linked, would respond differently to seismic shaking. The horizontal irregularity arises from the fact that the eastern bay of the building is cantilevered. Large cantilever transfer beams extend out to the east at Levels 12 to 14 above Tattersalls Lane to support the car park floors. Two of these cantilevered transfer beams sit on top of the key supporting shear wall (wall D5-6).

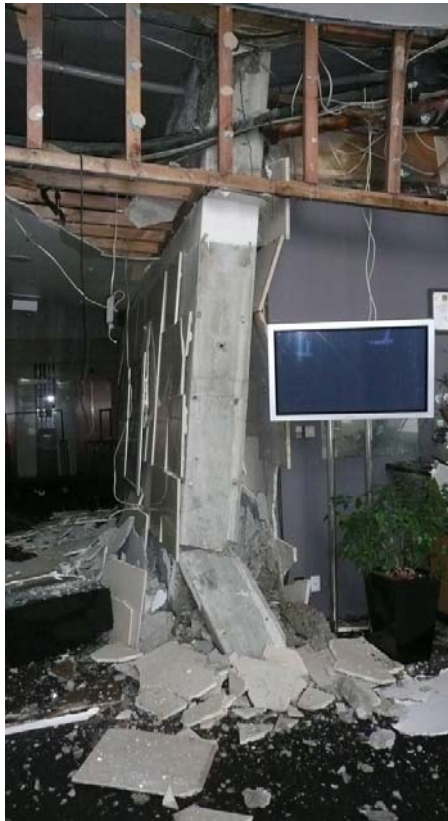
During the approximate 12 seconds of intense shaking that occurred in the 22 February 2011 aftershock, the Hotel Grand Chancellor building suffered a major structural failure with the brittle rupture of a shear wall (D5-6, refer Figure 3) in the south-east corner of the building. This shear wall provided vertical support for approximately one-eighth of the building's mass and was also expected to carry a portion of lateral earthquake loads. Damage to the base of the shear wall is shown in the photograph in Figure 4.

Figure 4: Shear wall D5-6 base failure (in the hotel foyer)

As a result of the wall failure, the south-east corner of the building dropped by approximately 800mm and developed an accompanying horizontal lean of approximately 1300mm at the top of the building. This major movement induced other damage including column failure at the underside of the podium, beam yielding, stair collapse and pre-cast panel dislodgement. The collapse of the stairs, in particular, was dependent on the wall failure. Other more minor structural damage was consistent with what may have been expected in a well-performing reinforced concrete structure in a seismic event of this nature.

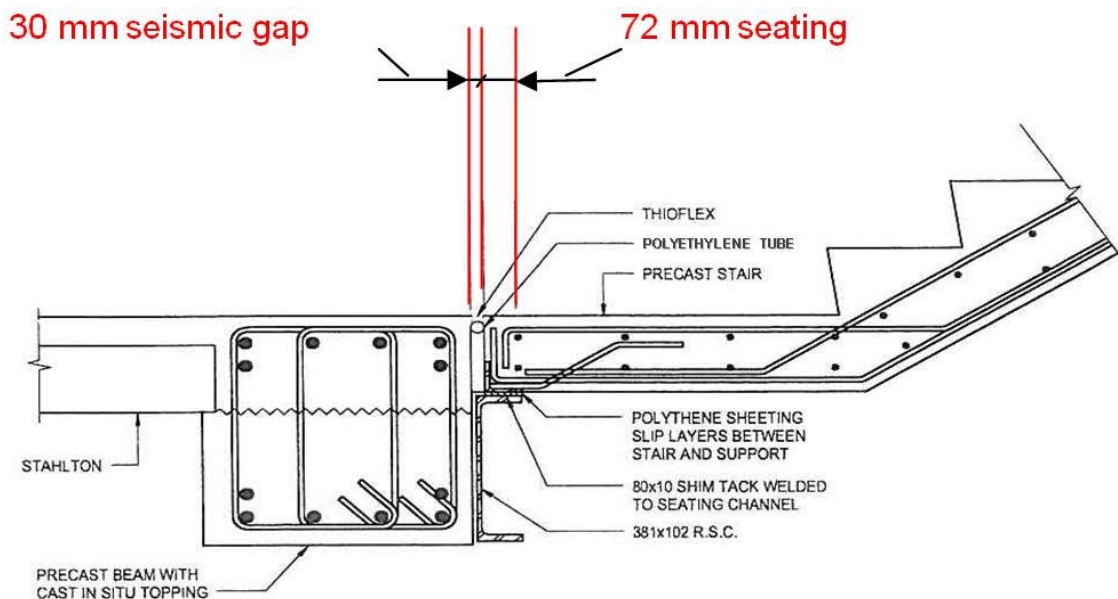
The stairs are orientated diagonally within the tower in a north-east/south-west direction. The majority of the stair flights were pre-cast units cast into the landing at their upper ends, and seated on a steel channel at their lower ends which, in an earthquake, allowed the lower end to slide within limits. This provided a horizontal gap specified at 30mm wide for the closing cycle and 73mm for opening (refer Figure 4).

Figure 4: Typical stair bottom support detail

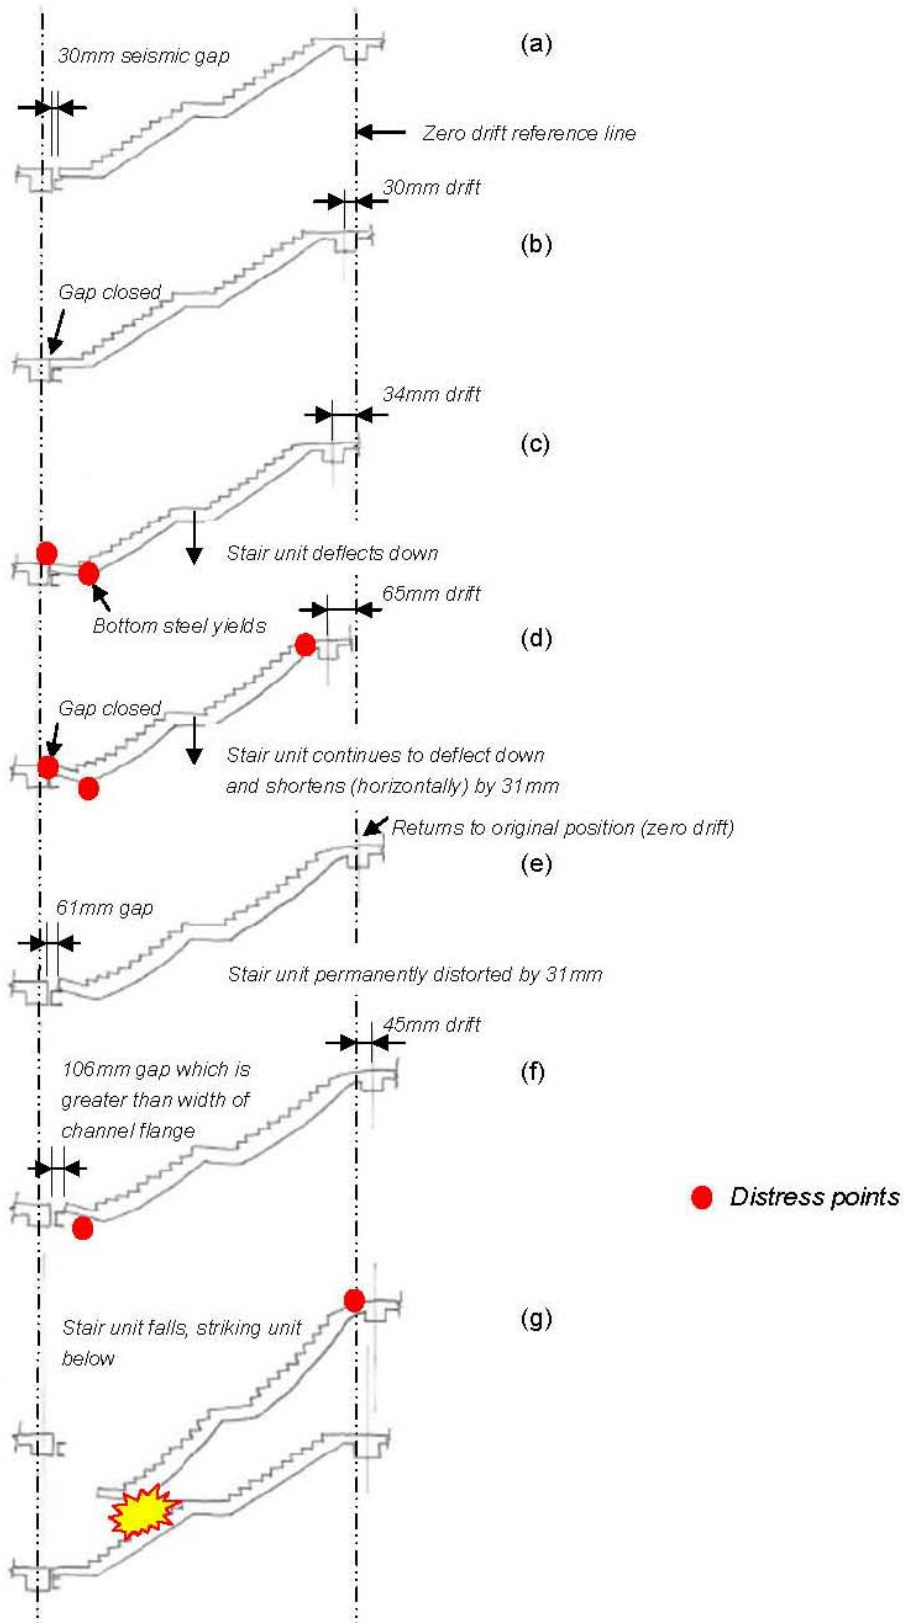
- The effective horizontal length of the stair unit was shortened when struck by the stair unit above, after the unit above lost its seating and rotated downwards about its upper landing. The consequent V-shaped lower unit would then have dragged its lower landing off its seat.

- A free-falling stair unit simply impacted the still-intact unit, causing it to fail catastrophically and fall.
- Construction tolerances and the possibility that the seismic gap at the lower stair support had been filled (with debris, mortar or polystyrene), would have reduced the level of building horizontal displacement required to fail the stair. Even though the stair separation gaps as designed met the code of the day, analyses indicate that the collapse would have occurred even if the joints had been fully free to move.

Figure 5: Inferred collapse sequence
