**Structural Performance
of
Christchurch CBD Buildings
in the
22 February 2011 Aftershock**

Stage 1 Expert Panel Report

**Pyne Gould Corporation Building
Hotel Grand Chancellor Building
Forsyth Barr Building**

30 September 2011

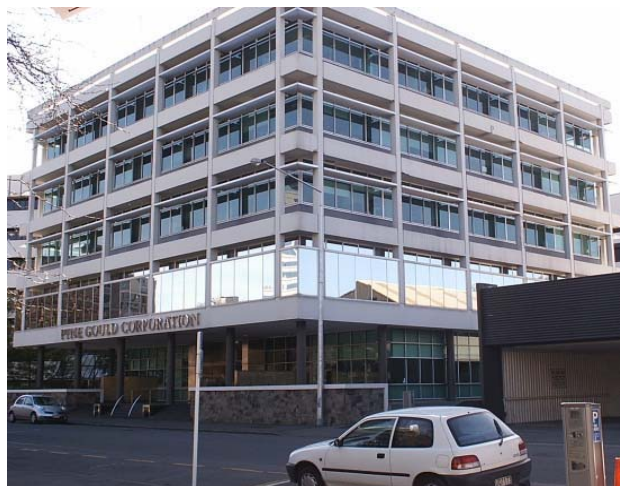
The building collapsed when the reinforced concrete walls of the core of the structure between Level 1 and Level 2 failed. Subsequently, the perimeter columns and/or joints between the columns and the beams and the connections between the floor slabs and the shear-core failed, causing the floors to collapse.

Figure 1: PGC Building prior to collapse (source: S. Tasligedik)

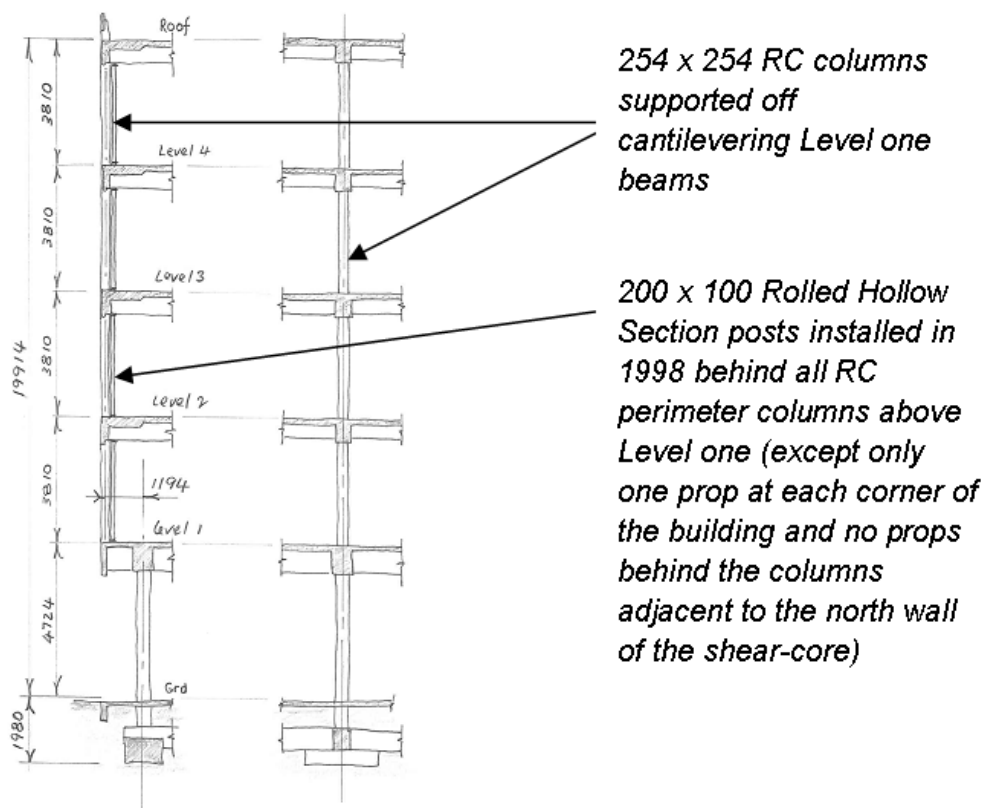
Figure 2: Section through building perimeter

The perimeter of the building above Level 1 was supported on reinforced concrete columns. These were supported on beams which were cantilevered beyond the ground floor reinforced concrete columns. Refer to Figure 2.

A feature of the building, that affected the way in which it responded to the 22 February 2011 aftershock, was that the structure between Ground Level and Level 1 was significantly stronger and stiffer than immediately above Level 1. Refer to Figures 3 and 4.

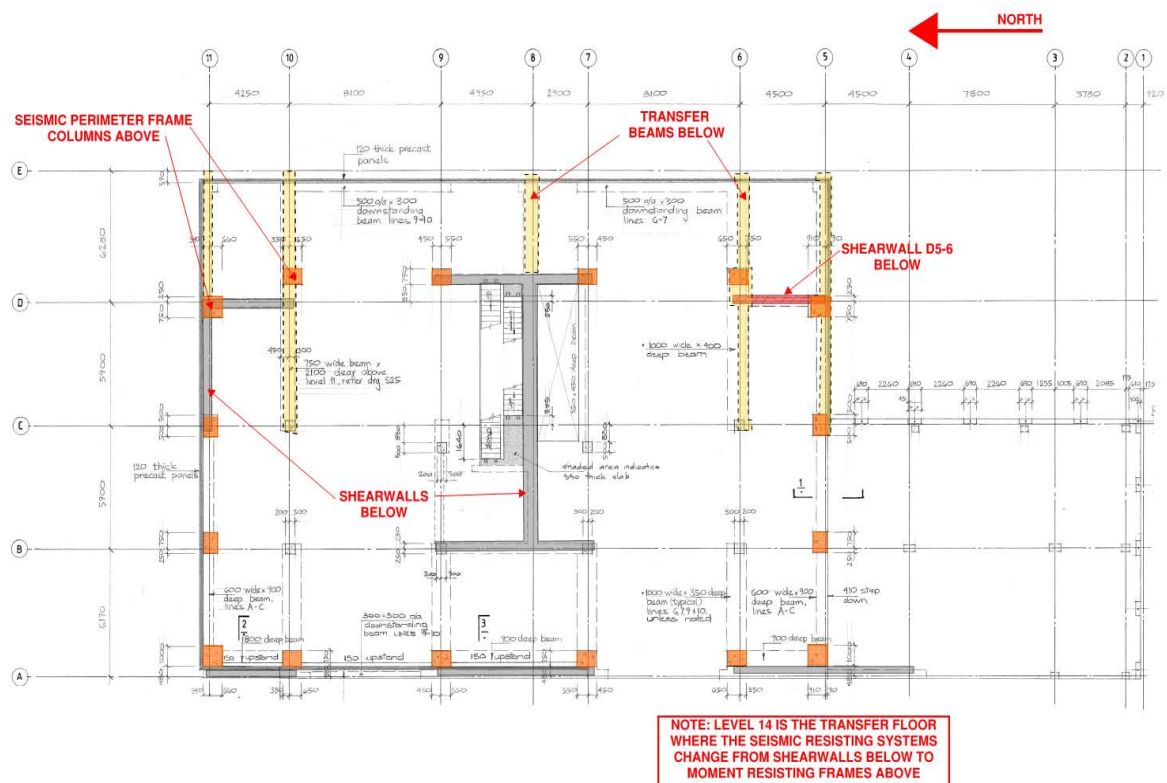
Figure 3: Level 14 floor plan

During the approximate 12 seconds of intense shaking that occurred in the 22 February 2011 aftershock, the Hotel Grand Chancellor building suffered a major structural failure with the brittle rupture of a shear wall (D5-6, refer Figure 3) in the south-east corner of the building. This shear wall provided vertical support for approximately one-eighth of the building's mass and was also expected to carry a portion of lateral earthquake loads. Damage to the base of the shear wall is shown in the photograph in Figure 4.

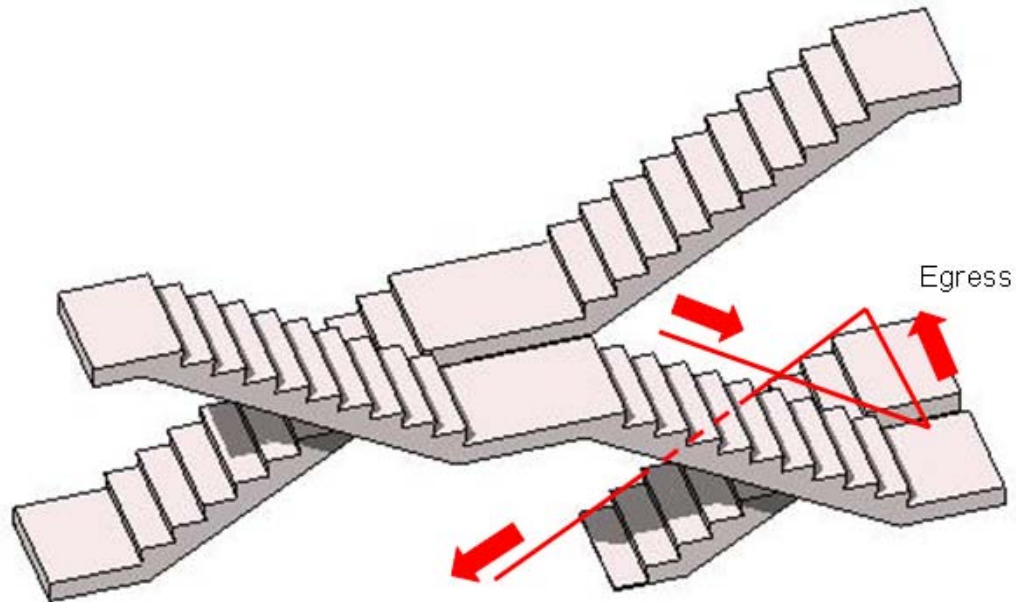
Figure 3: 3D view of typical Scissor Stair System between two adjacent levels

The stairs are orientated diagonally within the tower in a north-east/south-west direction. The majority of the stair flights were pre-cast units cast into the landing at their upper ends, and seated on a steel channel at their lower ends which, in an earthquake, allowed the lower end to slide within limits. This provided a horizontal gap specified at 30mm wide for the closing cycle and 73mm for opening (refer Figure 4).
