Guidance on house repairs and reconstruction following the Canterbury earthquake

**A summary of geotechnical and structural
engineering recommendations to guide
house repairs and reconstruction**

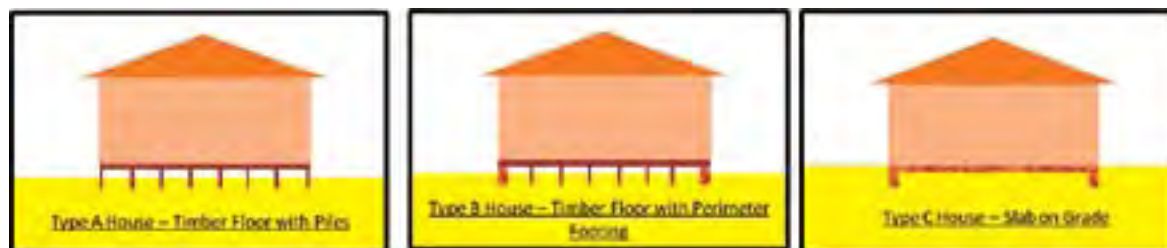
Figure 3.2: Dwelling Types A, B and C

Type A	Timber framed suspended timber floor structures supported only on piles
Type B	Timber framed suspended timber floor structures with perimeter concrete foundation
Type C	Timber framed dwelling on concrete floor

The apparent damage to Type A buildings is generally easier and less costly to repair, provided there has not been sufficient lateral spreading to cause the piles to detach from the floor system and punch through the floor. Type C buildings are typical of the newer subdivisions of Kaiapoi, Bexley and Brooklands, with a significant number of buildings being less than 10 years old. These buildings are typically supported on a shallow reinforced concrete perimeter strip footing, with concrete cast-on-grade floors. The floors are, in many cases, unreinforced, and not tied in to the perimeter foundations. These foundation and flooring systems have been observed to perform poorly in those areas that have undergone land deformation. In addition, such buildings will be difficult and more costly to repair.

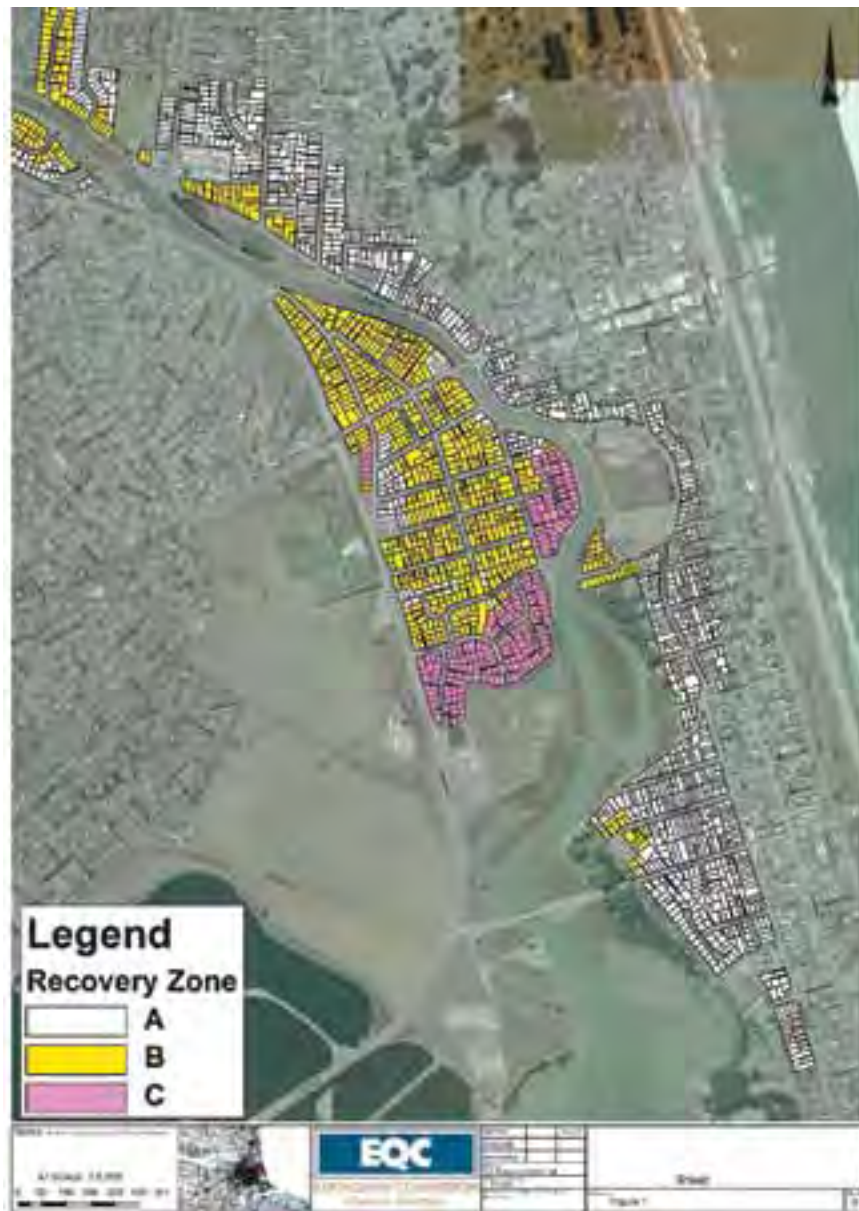
Figure 3.3: Example of Bexley Recovery Zone map

An example representation of the land recovery zoning is shown in Figure 3.3.

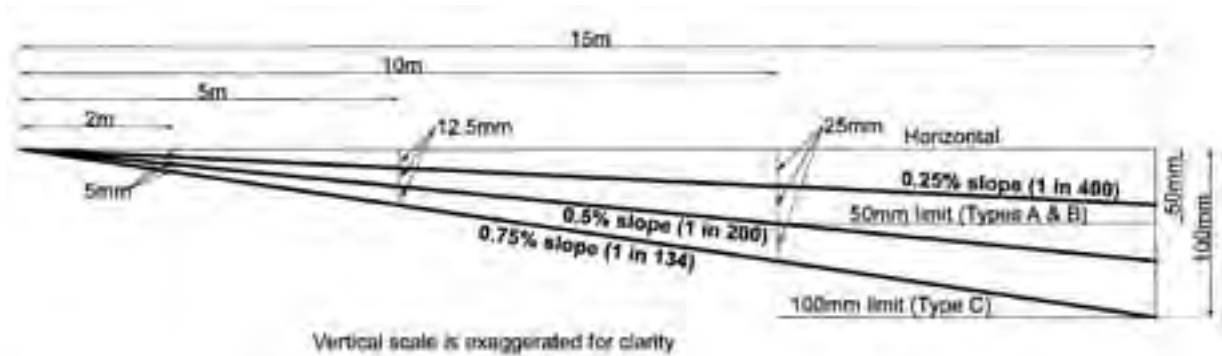
Figure 4.1: Diagrammatic representation of slope and category criteria

- (a) Reasoning covers human perception, and more applicable than overall slope
- (b) Note that for veneer cladding, there may be a need to rebuild the veneer
- (c) Pile packing unstable at greater than 50 mm
- (d) For most fully timber framed buildings, an overall stretch of less than 50 mm can be pulled together again
- (e) Where perimeter concrete foundation beams are present, there is unlikely to be an opportunity to pull the foundation together again
- (f) This is an economic decision for each property

Note that beyond 10 m, the 50 mm criteria governs over the 0.5% criteria

The different slope criteria are represented in Figure 4.1 overleaf.

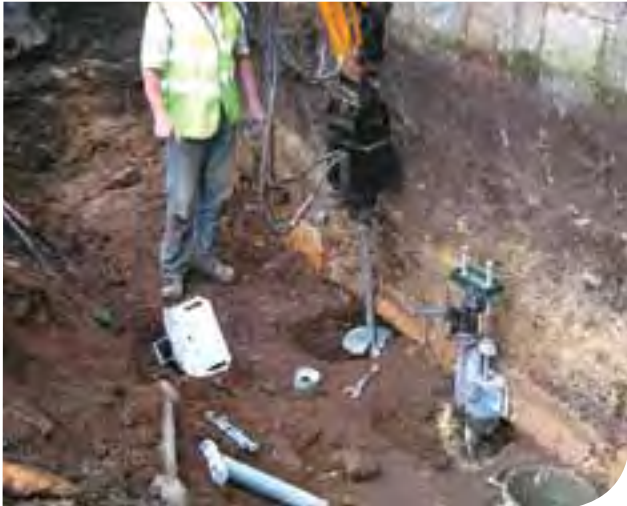
- Lifting Option 2: Perimeter foundation jacking using piles (screw or similar)

Foundation re-levelling using screw piles involves installing piles at discrete locations to the perimeter of the foundation wall, and installing under-beam shoes fitted with jacks to raise the foundation to the correct level. With the foundation repositioned, flowable grout is introduced to the cavity created under the raised foundation. Once the grout is cured the jacks are removed, and the screw piles removed. The screw piles may also be used as a permanent support.

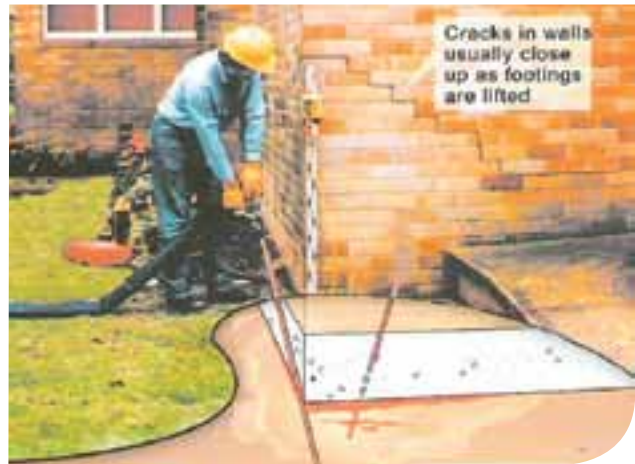
- Lifting Option 3: Perimeter foundation jacking using engineered resin

This option is a proprietary lifting process where engineered resin is injected into the ground at multiple points along the foundation. The expanding resin lifts the foundation. The process also densifies the surrounding ground which serves as a reaction layer for the lifting operation.

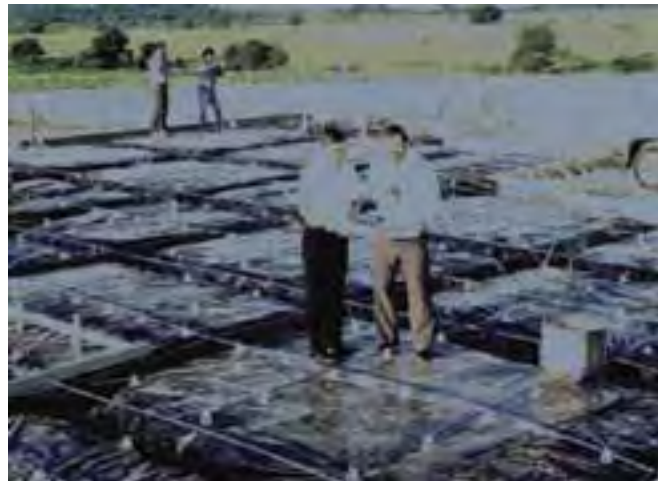
Option 4 – Construct a stiffened waffle slab over the existing soil.

The ground immediately beneath the polystyrene and ribs must have a minimum ultimate bearing strength of 300 kPa, or the system should be subject to specific engineering design.
