- **Proposed Changes to B2/AS1**
Report to Building Industry Authority

Attachment 3:
Report on E2/AS1 Risk Matrix and Weathertight Homes
Resolution Service Data

November 2003

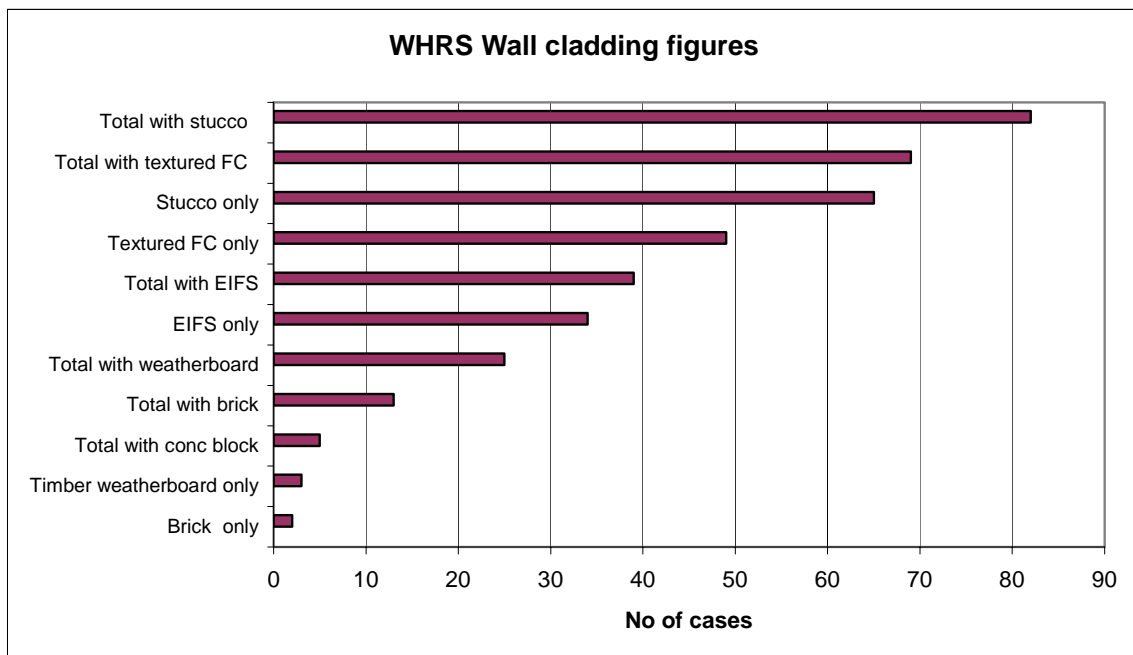
Figure 1: WHRS Cladding Distribution

The distribution of cladding types is shown in Figure 1:

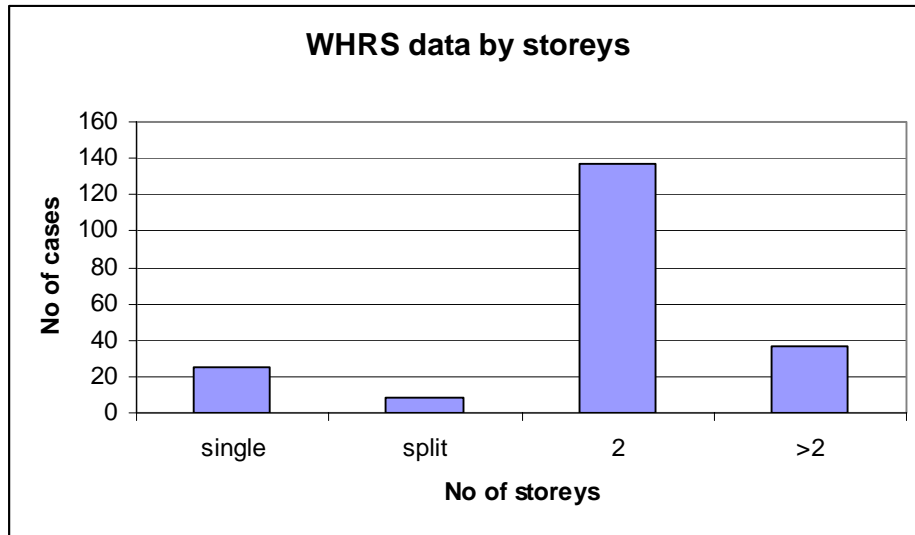
Figure 2: WHRS data by storeys

The distribution of leaky buildings by number of storeys is shown in Figure 2

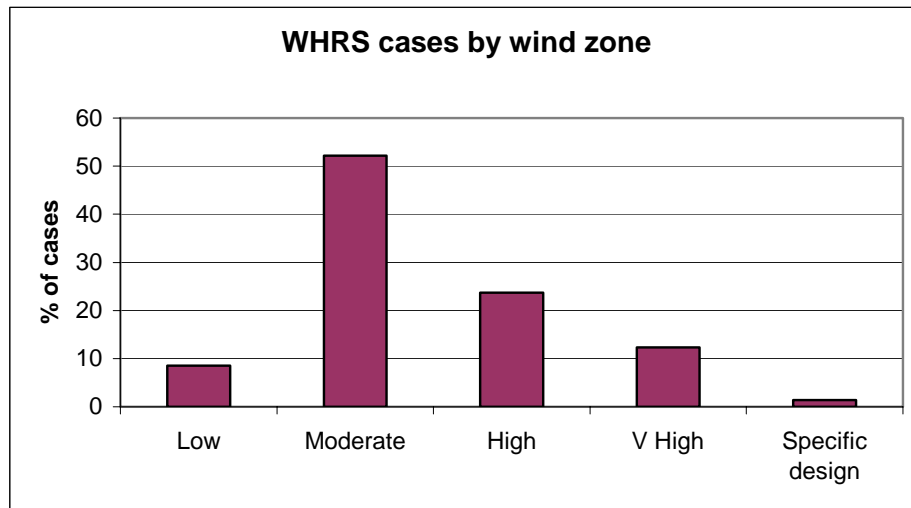
Figure 3: WHRS wind zone cases

The distribution of leaky buildings by wind zone is shown in Figure 3:

The data from the analysis of BRANZ reports and anecdotal feedback from building assessors do not show a strong relationship between wind zone and the incidence of leaky buildings. As shown in Figure 3, initial data provided by WHRS also provides no clear indications of wind zone effects.

Taking this uncertainty into consideration, it is recommended that, while Wind zone should be included in the risk matrix, the weighting given to it should be less than that for those factors with a more reliable positive connection with leaks.

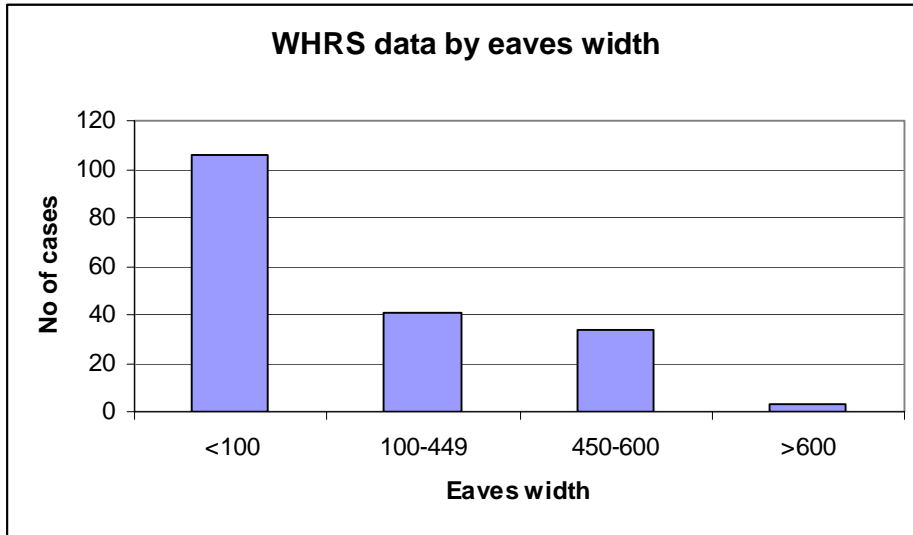
Figure 4: WHRS data by eaves width

The distribution of leaky buildings by eaves width is shown Figure 4:

It should be noted that, due to the way the eaves width is recorded in the summary sheet, there is a higher degree of uncertainty over this data than other parts of the database.

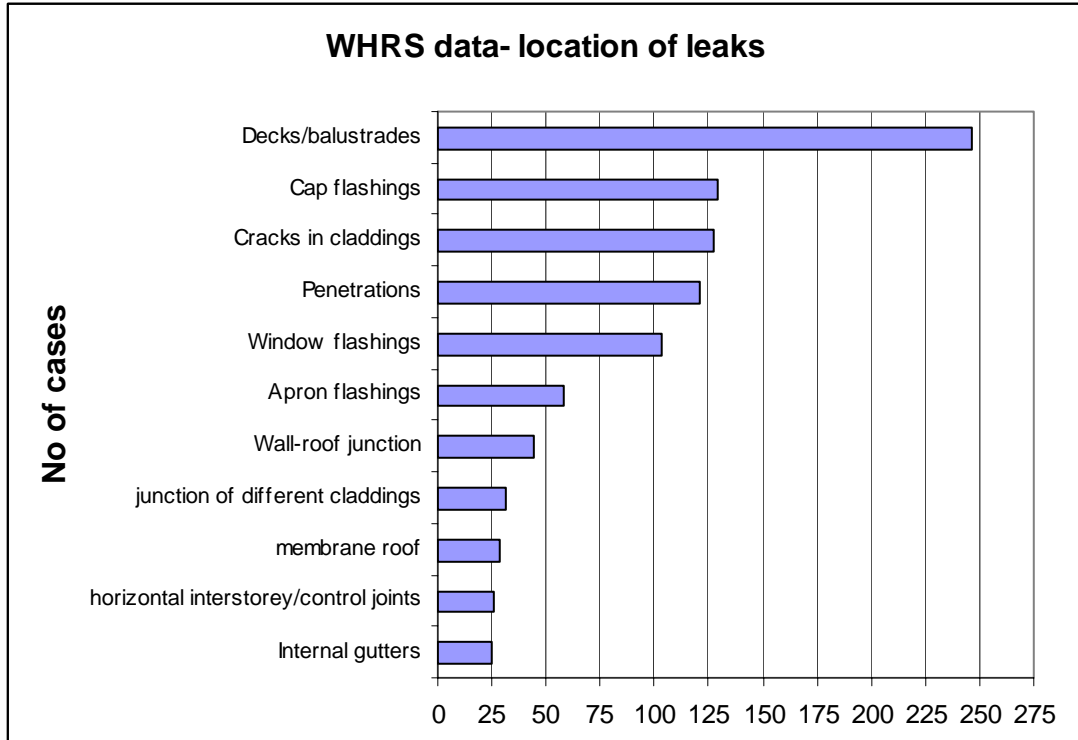
Figure 5: WHRS data: Location of leaks

Figure 5 shows the location of leaks in the WHRS data.

It should be noted that a building may have several component parts causing leaks and several leaks associated with each component. This explains why the total of some leak sources exceeds the number of buildings.

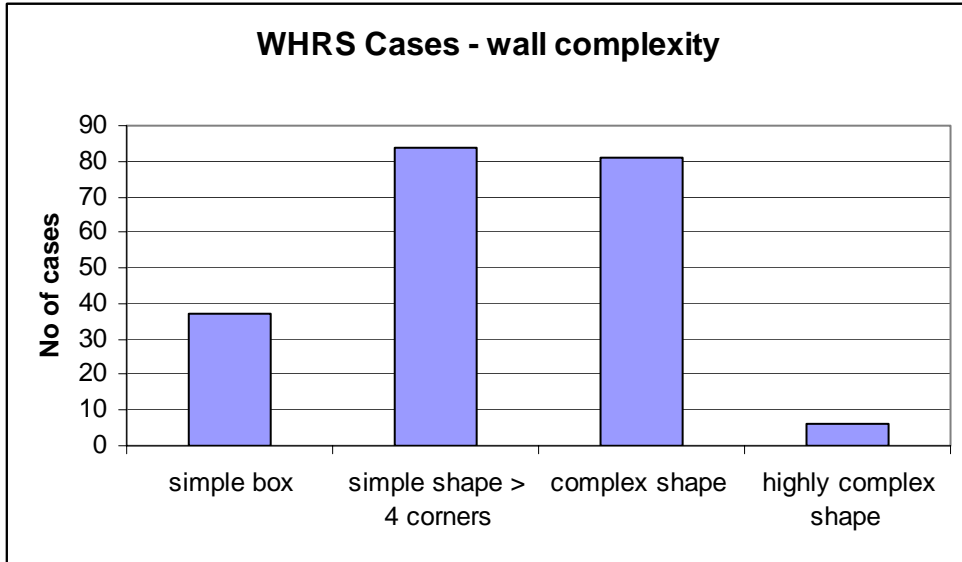
Figure 6: WHRS Cases - wall complexity

Figure 6 shows the distribution of WHRS cases by wall complexity.

Wall complexity attempts to use the building form to define the effect on the risk of leaks of the number and difficulty of junctions and penetrations associated with the walls (but not expressly covered by decks/balconies). This factor has been retained in the risk matrix.

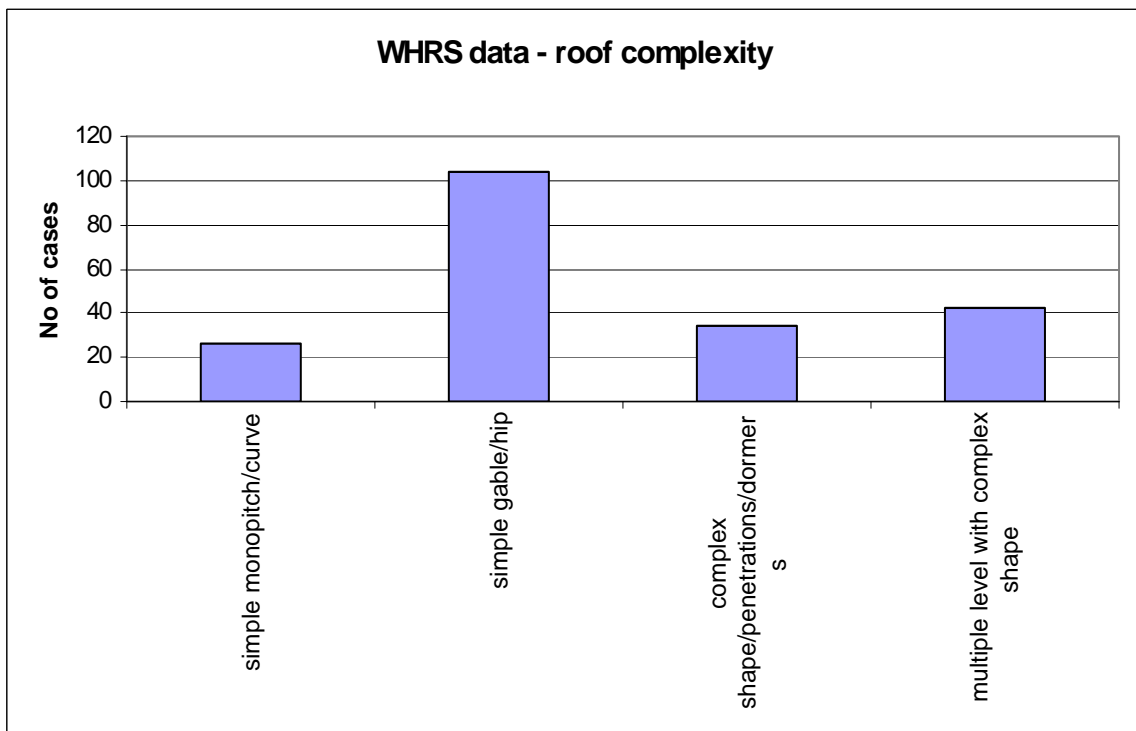
Figure 7: WHRS data - roof complexity

Figure 7 shows the WHRS data broken down by roof complexity.

However complex roofs frequently intersect with walls on upper floors, creating opportunities for leaks to penetrate directly into the wall. Defining a series of parameters to cover roof complexity is not a simple task but has been attempted in the risk matrix.

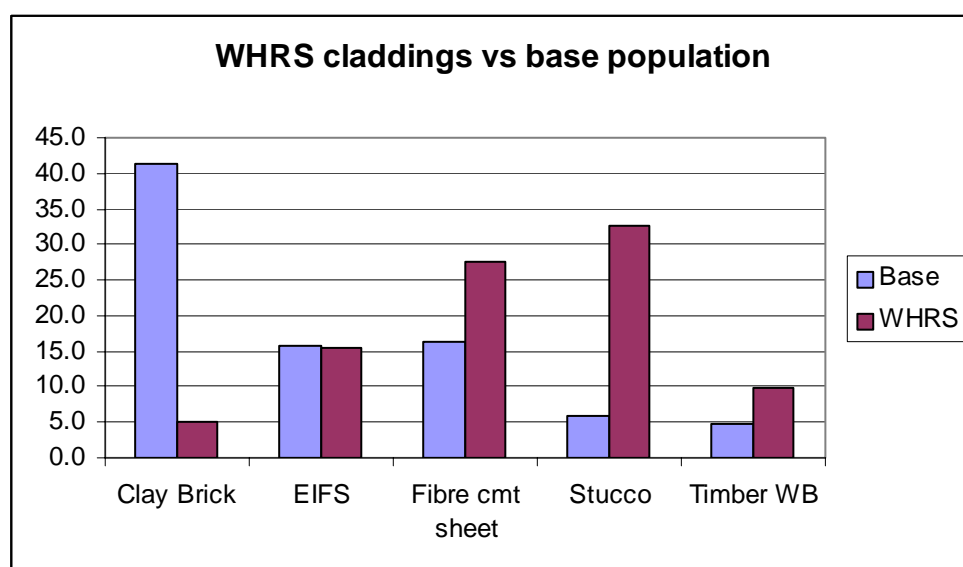
Figure 8: WHRS claddings versus base population

Figure 8 shows the WHRS cladding distribution alongside the base population.

The main features of Figure 8 are that brick veneer is substantially under represented in the WHRS while stucco is substantially over represented.

For simplicity, the main cladding types in the WHRS have been counted both as the sole cladding and in all instances where they occur with other claddings. The numbers were then pro-rated back to 100% to reduce the effect of double counting. This data was then compared to the base data.

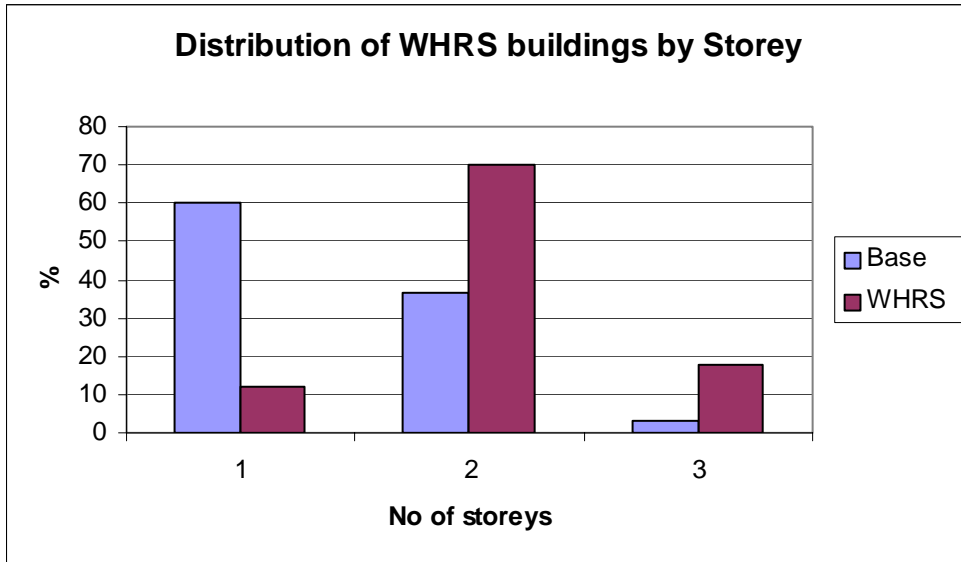
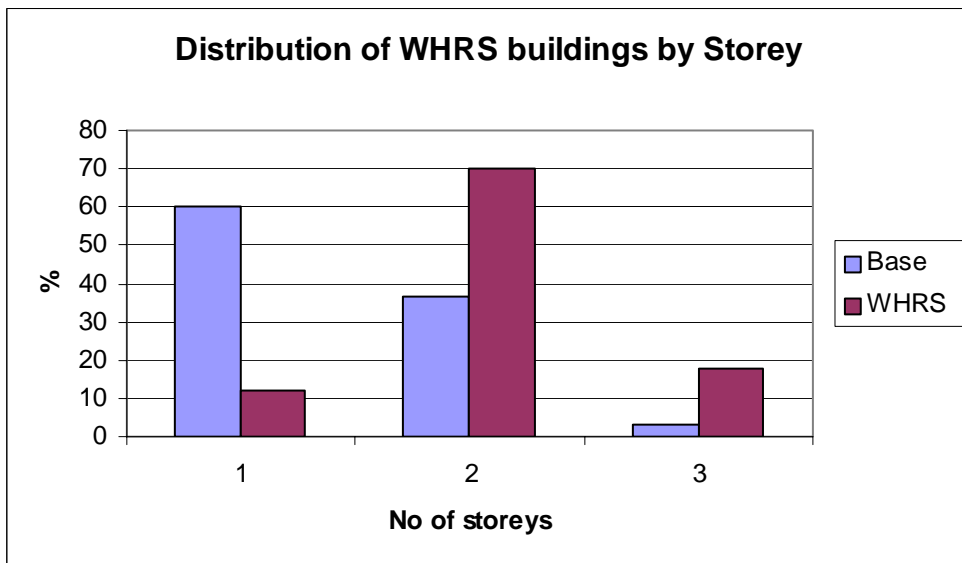
Figure 9: WHRS Storeys versus base population

Figure 9 shows the distribution of storey height in the WHRS data versus the base population.

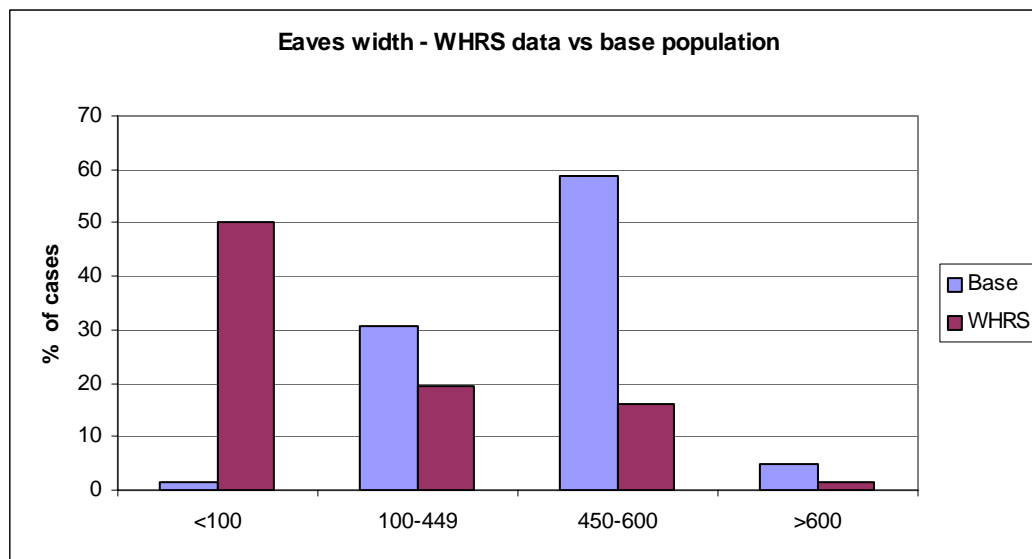
Figure 10: Eaves width - WHRS data versus base population

Figure 10 shows the distribution of eaves widths in the WHRS data versus the base population.

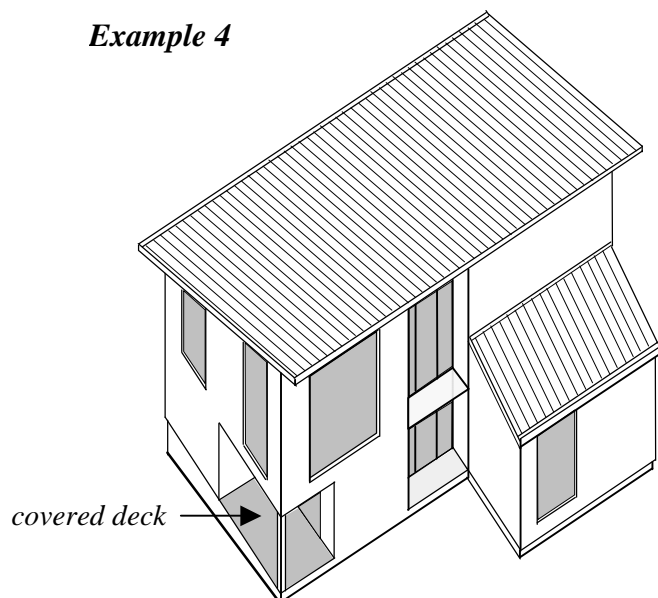
Example 4

Risk Score	Low		Medium		High		Very High		
Wind zone (NZS3604)	Low	0	Medium	0	High	1	1	Very High	2
No. of storeys	One	0	Part two storey	1	Two	2	2	More than two	4
Roof type	Hip	0	Gable without eaves	1	1	complex shape/ dormers	3	Multiple level with complex shapes or parapet	5
Eave width (ignore if parapet)	Low risk	0	Medium risk	1	High risk	2	Very high risk	5	5
Envelope complexity	Simple	0	Moderate	1	Moderately complex	3	3	Complex	6
Decks/ Balconies	Low risk	0	Medium risk	2	2	High risk	4	Very high risk	6
Subtotals		0	+	3	+	6	+	5

Total E2/AS1 Risk Score 14

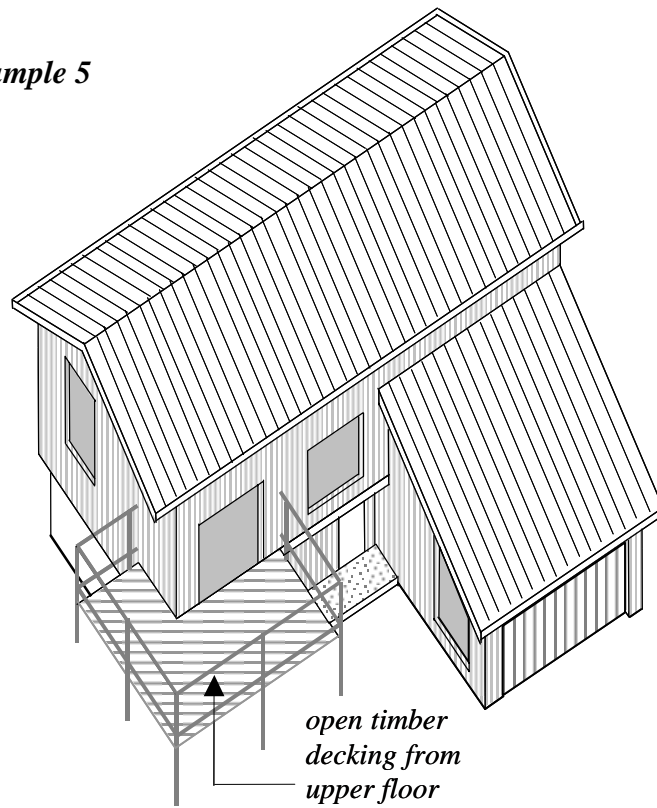
Example 5

<i>Risk Score</i>	Low		Medium		High		Very High		
Wind zone (NZS3604)	Low	0	Medium	0	High	1	1	Very High	2
No. of storeys	One	0	Part two storey	1	1	Two	2	More than two	4
Roof type	Hip	0	Gable without eaves	1	1	complex shape/dormers	3	Multiple level with complex shapes or parapet	5
Eave width (ignore if parapet)	Low risk	0	Medium risk	1		High risk	2	Very high risk	5
Envelope complexity	Simple	0	Moderate	1	1	Moderately complex	3	Complex	6
Decks/Balconies	Low risk	0	Medium risk	2	2	High risk	4	Very high risk	6
Subtotals		0	+	5		+	1	+	5

Total E2/AS1 Risk Score 11

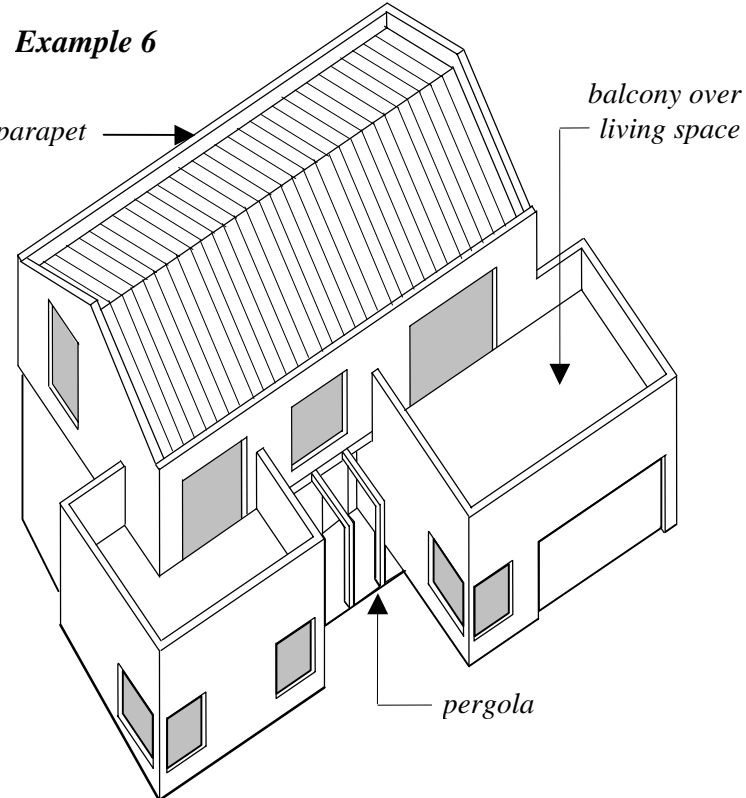
<i>Risk Score</i>	Low		Medium		High		Very High		
Wind zone (NZS3604)	Low	0	Medium	0	High	1	1	Very High	2
No. of storeys	One	0	Part two storey	1	Two	2	2	More than two	4
Roof type	Hip	0	Gable without eaves	1	complex shape/dormers	3	5	Multiple level with complex shapes or parapet	5
Eave width (ignore if parapet)	Low risk	0	Medium risk	1	High risk	2		Very high risk	5
Envelope complexity	Simple	0	Moderate	1	Moderately complex	3	6	Complex	6
Decks/Balconies	Low risk	0	Medium risk	2	High risk	4		4	Very high risk
Subtotals		0	+	0	+	7	+	11

Total E2/AS1 Risk Score 18

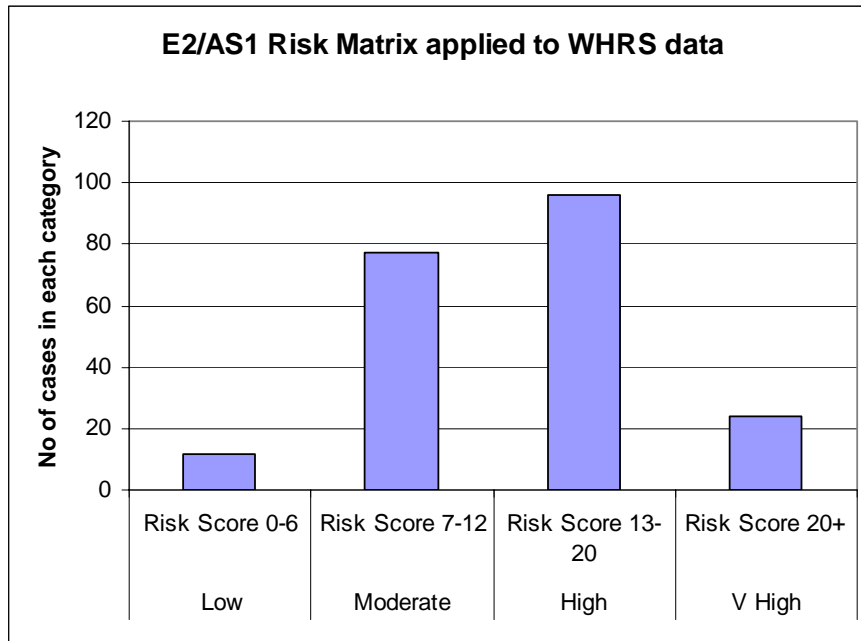
Figure 11: WHRS data in risk matrix

The WHRS information was used in the revised risk matrix, and the resulting risk categories are shown in Figure 11:

The presence of low risk buildings showing up in the data may appear surprising at first. However, even relatively simple houses still require proper detailing of windows and junctions etc. Of the low risk buildings in the WHRS data, 7 leaked at window flashings, 2 leaked at internal gutters and 5 had cracks in cladding.

In the moderate risk group, most buildings were clad with either monolithic cladding or monolithic claddings in conjunction with another cladding. The major sources of leaks in this group were; cracks in the cladding system (47), window flashings (40), leaks in cap flashings (22), saddle flashings (13) and roof to wall junctions (9). Note that cracks in claddings can be a symptom of water entry as well as a cause. For example, water entering from a flashing defect will cause timber framing to get wet and expand. This in turn can stress the joints between claddings leading to cracks.

In the high-risk group, like the moderate risk group, most buildings were clad with either monolithic cladding or monolithic claddings in conjunction with another cladding. The main sources of leaks were located around balconies or decks with cap flashings (58), deck to wall junctions (38), cracks in cladding system (38), balustrade/parapet wall junctions (38) and fixing through cap flashings (26).

All houses in the very risk group had a monolithic cladding (one had EIFS and concrete block). The main locations of water leakage were; cracks in cladding system (20), deck to wall junctions (18), apron flashings (14) and wall to roof intersections (11).
