Egress Stairs: Earthquake checks needed for some

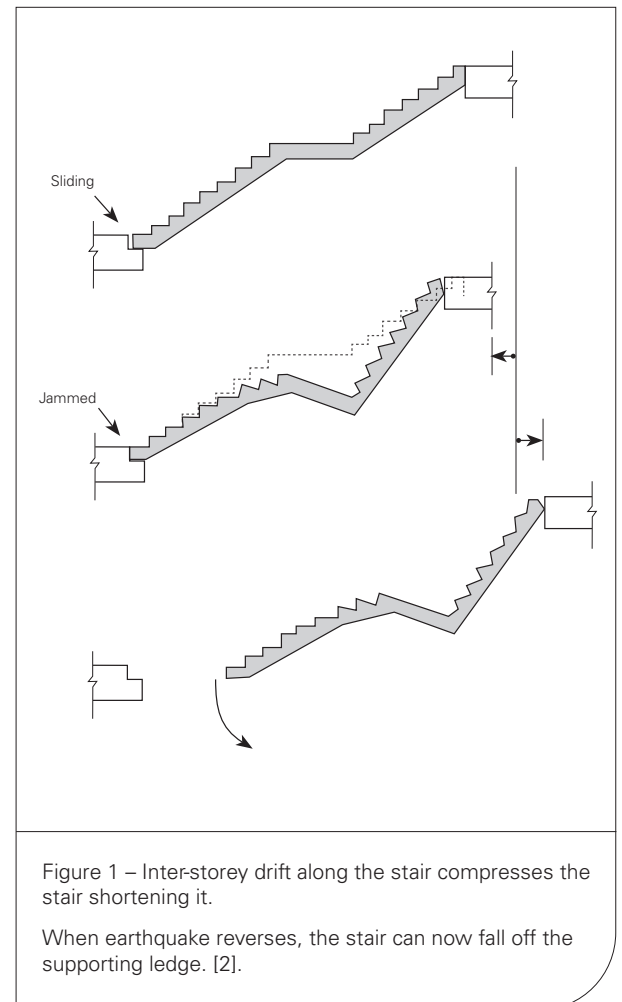
- Calculate the inter-storey drifts as per Item 2 above.
- Check if the movement causes the sliding end of the stair to impact against the support (wall, beam or landing) - see Figure 1.

- If the lateral movement of the stair closes the gap, causing impact on the support/landing:
 - Look to increase the gap.
 - Check implications of bracing action as the stair struts between floors, if gap should close:

- on the stair flight
 - on the supports at each end of the stair
 - on the building, as the stairs can significantly stiffen the building through the bracing action between floors, via unintended load paths. This results in the building attracting seismic forces that may be much larger than originally considered in the design of the building.

- Check gap left for closing movement of the stairs:
 - Check for objects in gap, such as debris or floor levelling compounds that may have occurred during earlier repairs/new fit-outs. Remove these obstructions.

- Modify detail to prevent further objects in the gap impeding movement. For example, cover plates over the gaps.
